City of Evansville **Historic Preservation Commission**
Regular Meeting
Wednesday, November 15, 2023
3rd Floor, City Hall, 31 S. Madison Street, Evansville, WI 53536
6:00 p.m.

Lake Leota Dam Spillway Repairs

City of Evansville, WI

**Lake Leota Dam Repairs
 Evansville, Wisconsin**

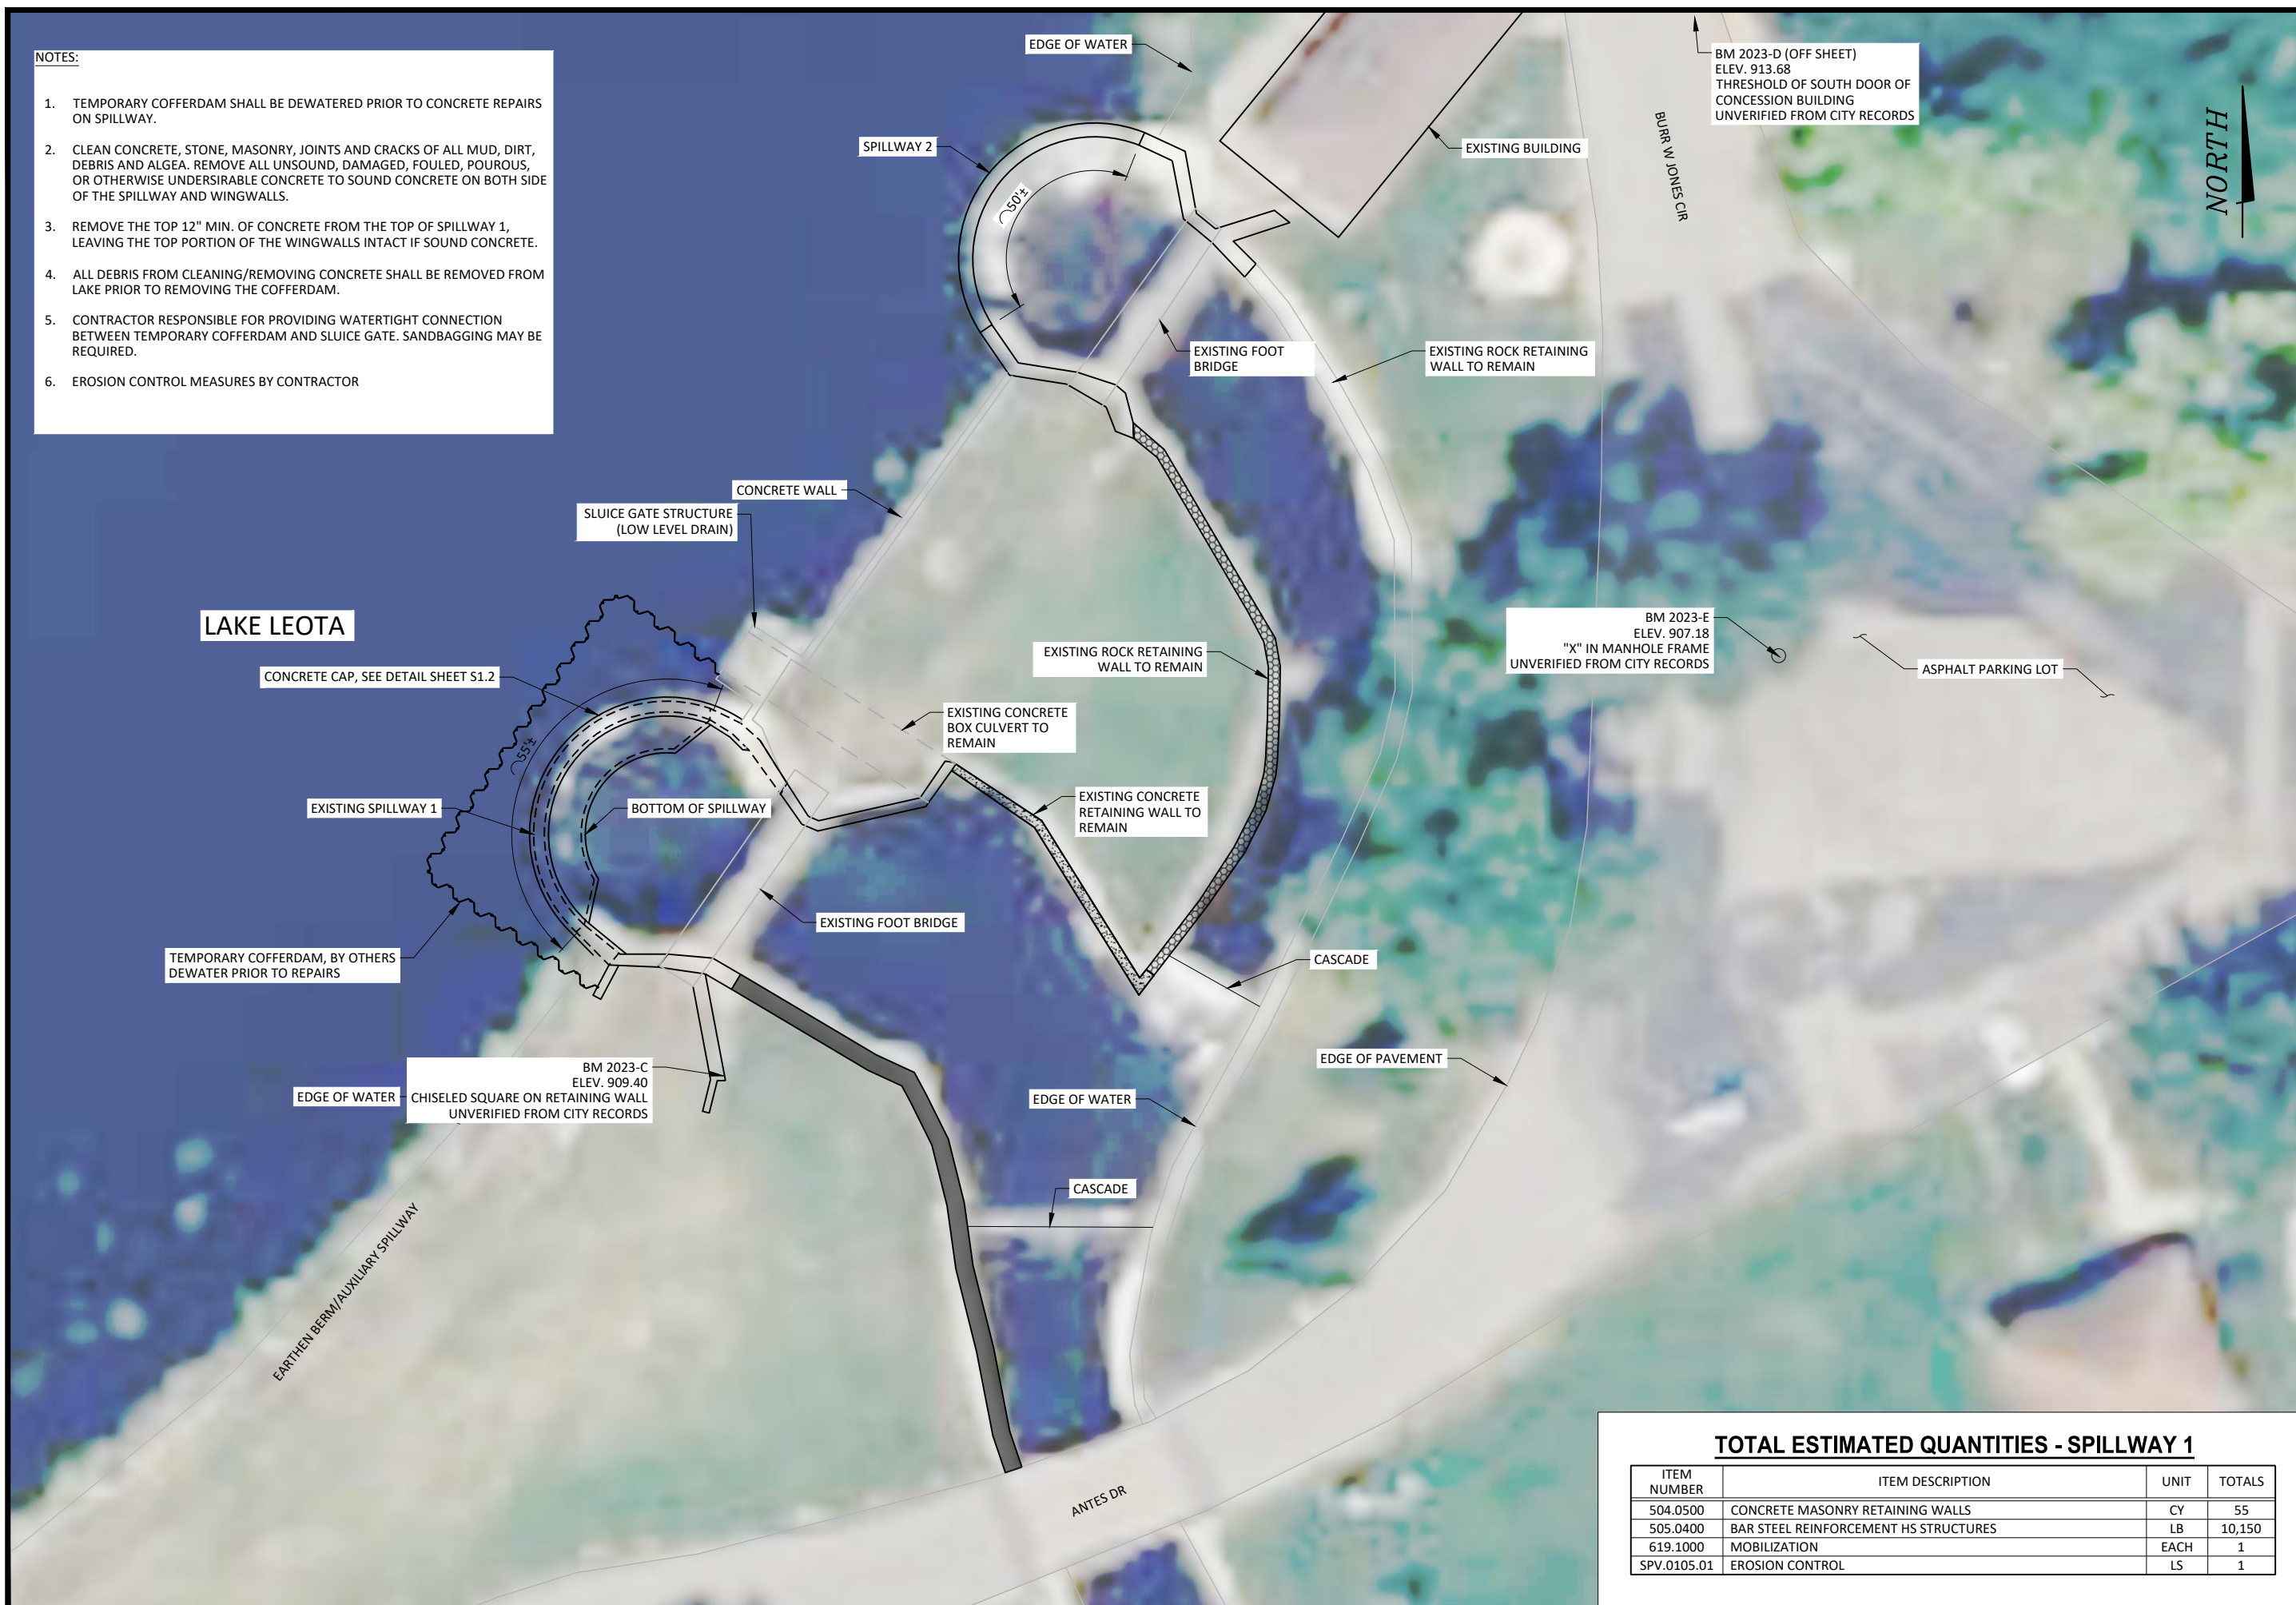
SPILLWAY 1 PLAN VIEW

TEMPORARY COFFERDAM BY OTHERS,
DEWATER PROIR TO REPAIRS

CONCRETE CAP

EXISTING SPILLWAY 1

BENTONITE STRIP
WATER STOP, CONT.

SLUICE GATE STRUCTURE
(LOW LEVEL DRAIN)

EXISTING CONCRETE
BOX CULVERT TO
REMAIN

- 1.1 TEMPORARY COFFERDAM 1 IS ALREADY INSTALLED.
- 1.2 PROVIDE WATERPROOF SEAL FOR TEMPORARY COFFERDAM 1.
- 1.3 DEWATER TEMPORARY COFFERDAM 1.
- 1.4 DREDGE LAKE BETWEEN TEMPORARY COFFERDAM 1 AND SPILLWAY 1.
- 1.5 DEWATER DOWNSTREAM SIDE OF SPILLWAY 1.
- 1.6 CLEAN BOTH SIDES OF EXISTING SPILLWAY 1. REMOVE ANY LOOSE DEBRIS, SOIL, SLURRY, ETC.
- 1.7 PREPARE EXISTING CONCRETE PER STANDARD SPECIFICATIONS.
- 1.8 INSTALL NEW SPILLWAY CAP PER PLANS.
- 1.9 ALLOW CONCRETE CAP ADEQUATE TIME TO CURE PER STANDARD SPECIFICATIONS AND REMOVE FORMS.
- 1.10 REWATER TEMPORARY COFFERDAM 1.
- 1.11 REMOVE TEMPORARY COFFERDAM 1 (BY OTHERS).

- 2.1 INSTALL TEMPORARY COFFERDAM 2 AT THE NORTH SPILLWAY (SPILLWAY 2)
- 2.2 DEWATER TEMPORARY COFFERDAM 2.
- 2.3 DREDGE LAKE BETWEEN TEMPORARY COFFERDAM 2 AND SPILLWAY 2.
- 2.4 DEWATER DOWNSTREAM SIDE OF SPILLWAY 2.
- 2.5 CLEAN BOTH SIDES OF EXISTING SPILLWAY 2. REMOVE ANY LOOSE DEBRIS, SOIL, SLURRY, ETC.
- 2.6 PREPARE EXISTING CONCRETE PER STANDARD SPECIFICATIONS.
- 2.7 INSTALL NEW SPILLWAY CAP PER PLANS.
- 2.8 ALLOW CONCRETE CAP ADEQUATE TIME TO CURE PER STANDARD SPECIFICATIONS AND REMOVE FORMS.
- 2.9 REWATER TEMPORARY COFFERDAM 2.
- 2.10 REMOVE TEMPORARY COFFERDAM 2.

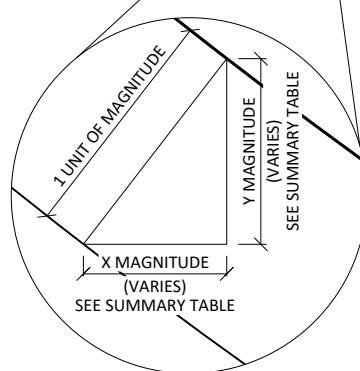
RESULTANT DETAIL

Drawing Name	SPILLWAY 2 FORCE RESULTANT
Sheet No.	S2
Project Number	E29120

SPILLWAY 2		
Node	Y Magnitude	X Magnitude
Middle	1.0000	0.0000
A	0.9990	0.0438
A'	0.9990	0.0438
B	0.9962	0.0876
B'	0.9962	0.0876
C	0.9914	0.1311
C'	0.9914	0.1311
D	0.9847	0.1745
D'	0.9847	0.1745
E	0.9761	0.2175
E'	0.9761	0.2175
F	0.9656	0.2600
F'	0.9656	0.2600
G	0.9533	0.3021
G'	0.9533	0.3021
H	0.9391	0.3436
H'	0.9391	0.3436
I	0.9232	0.3844
I'	0.9232	0.3844
J	0.9054	0.4245
J'	0.9054	0.4245
K	0.8860	0.4638
K'	0.8860	0.4638
L	0.8648	0.5022
L'	0.8648	0.5022
M	0.8419	0.5396
M'	0.8419	0.5396
N	0.8175	0.5760
N'	0.8175	0.5760
O	0.7915	0.6112
O'	0.7915	0.6112
P	0.7639	0.6453
P'	0.7639	0.6453
Q	0.7349	0.6782
Q'	0.7349	0.6782
R	0.7045	0.7097
R'	0.7045	0.7097
S	0.6727	0.7399
S'	0.6727	0.7399
T	0.6396	0.7687
T'	0.6396	0.7687
U	0.6053	0.7960
U'	0.6053	0.7960
V	0.5698	0.8218
V'	0.5698	0.8218
W	0.5333	0.8459
W'	0.5333	0.8459
X	0.4957	0.8685
X'	0.4957	0.8685
Y	0.4571	0.8894
Y'	0.4571	0.8894
Z	0.4177	0.9086
Z'	0.4177	0.9086
AA	0.3775	0.9260
AA'	0.3775	0.9260
BB	0.3366	0.9417
